Property Visit Report

10 Rosewood Avenue, Prestwick, Ayrshire KA9 1LA

Report date: 28th August 2023

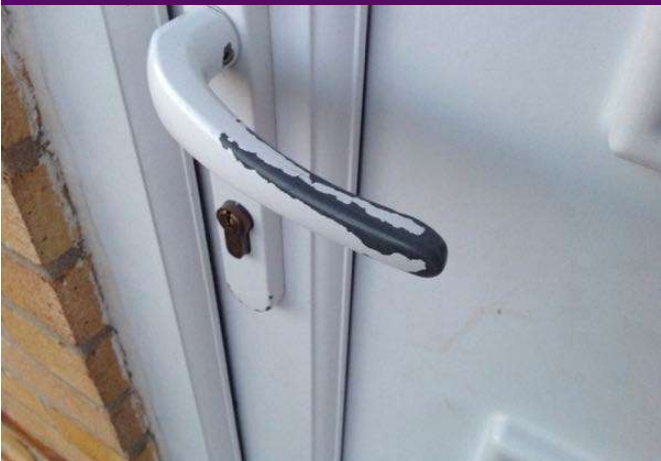
28-08-2023 13:55 / External Front Door / 7pyiy2zki

Handle showing signs of wear

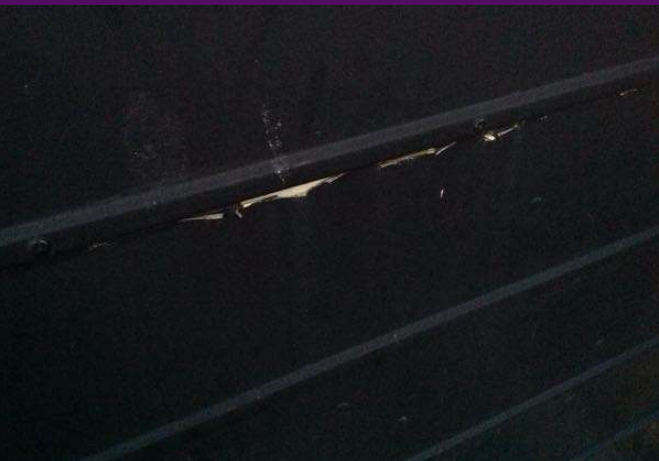
28-08-2023 13:56 / Garage / Cjyc1sty6

Garage door paint is flaking

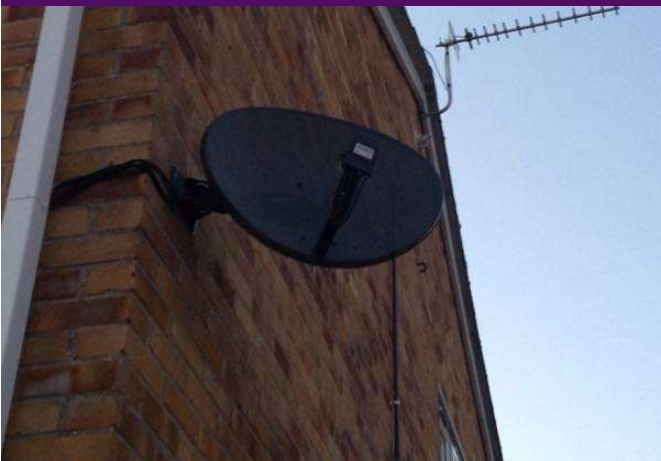
28-08-2023 13:56 / Satellite Dish / 8r5nqsfqu

Satellite dish? OK

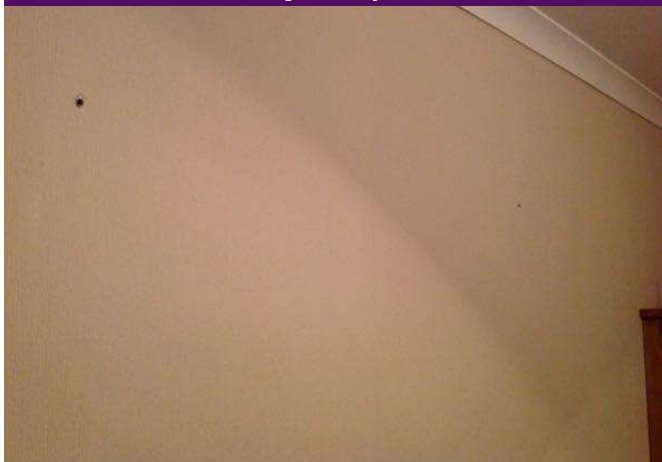
28-08-2023 13:57 / Walls Ceilings / Z0rrxy8ts

Walls and ceiling	Fair	Flooring	Good
2 Screw holes in wall.			
Photo code: z0rrxy8ts			
Woodwork and doors	Fair	Windows and sills	Fair
Landlord's furnishings	Good

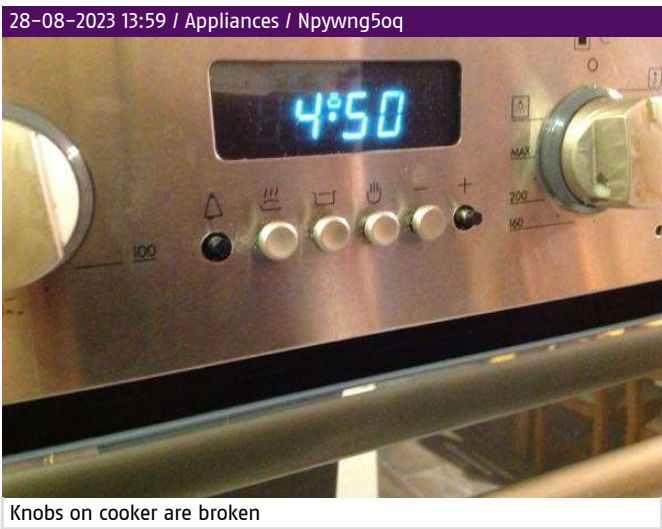
Knobs on cooker are broken

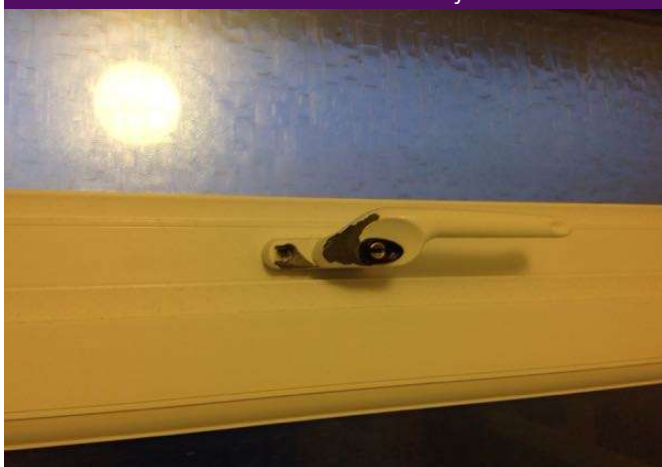
28-08-2023 14:02 / Bathroom Windows Sills / 85iy1xn9a

Handle broken on window

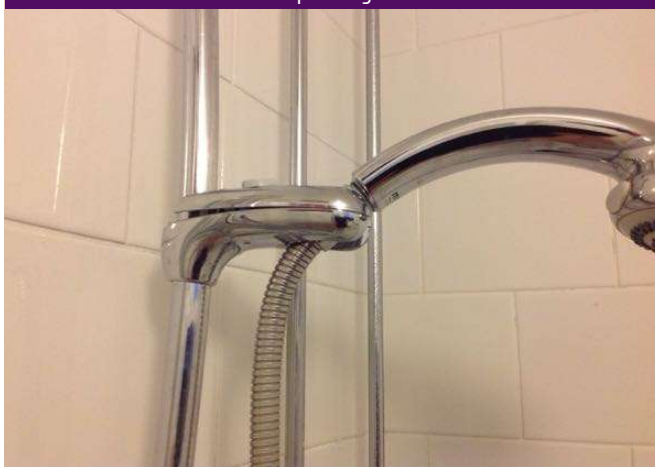
28-08-2023 14:03 / Shower / Kqb64uf1g

Walls and ceiling	Good	Flooring	Good
Woodwork and doors	Good	Windows and sills	Fair
		Handle broken on window	
		Photo code: 85iy1xn9a	
Shower and attachments	Fair	Silicone seals	Fair
Broken shower attachment.			
Photo code: kqb64uf1g			
Tiles and grout	Fair		
Bath seal is mouldy			
Photo code: hlpbb4eco

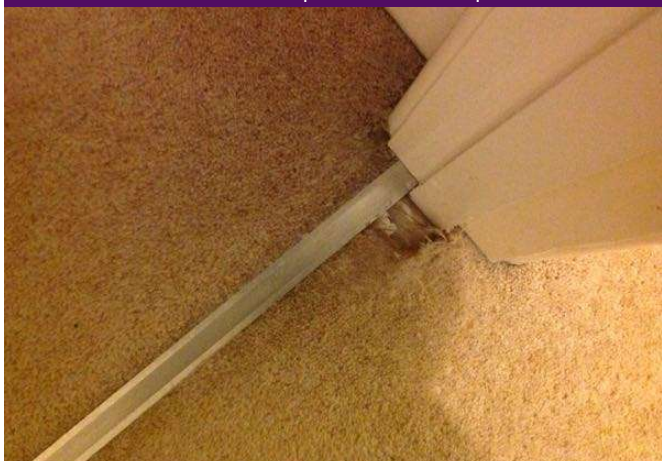
28-08-2023 14:04 / Bedroom Carpets Floors / 07a7rq0mm

Walls and ceiling	Good	Flooring	Fair
		Damage to carpet	
		Photo code: o7a7rq0mm	
Woodwork and doors	Good	Windows and sills	Fair

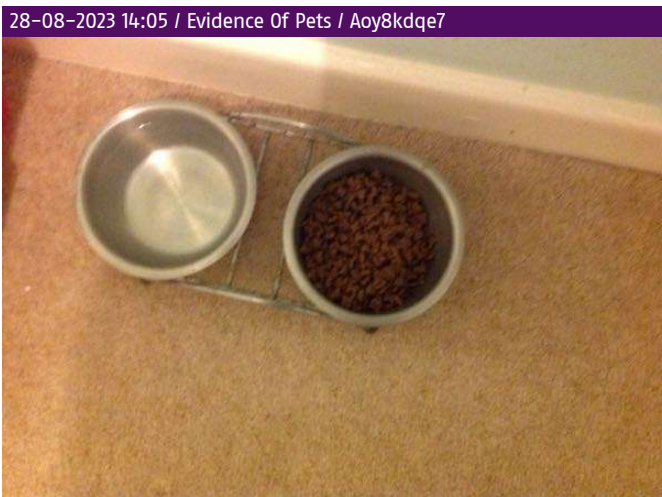
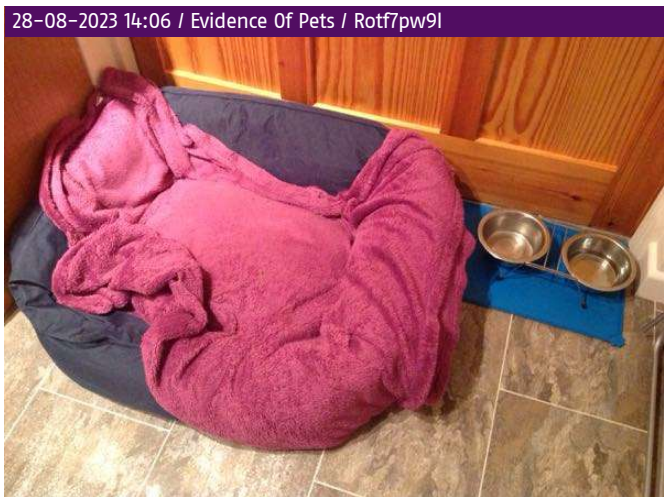
Pets?	Yes	Hoarding?	No
Evidence of 1 cat and 1 dog			
Photo codes: aoy8kdqe7, rotf7pw9l			
Smoking?	No	Business activity?	No
Malicious damage?	No	Attic inspected?	Yes
